Manhole Inspection Summary

Manhole # S27S__009MH

Insp Date: **4/25/08 11:38 AM**

Location Address: **1620 Bush st**

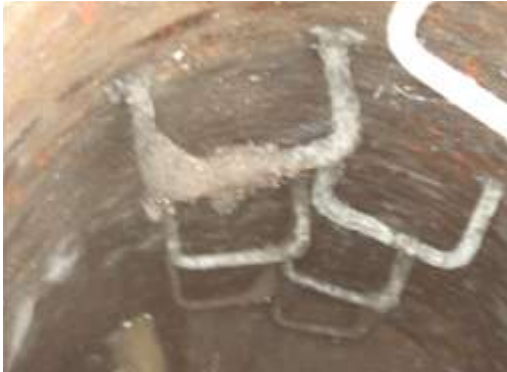
Defect 7

Infiltration: ☐ None ☐ Joint ☐ Cracks ☐ Mortar ☐ Roots ☒ **Wall**

signs of infiltration on barrel

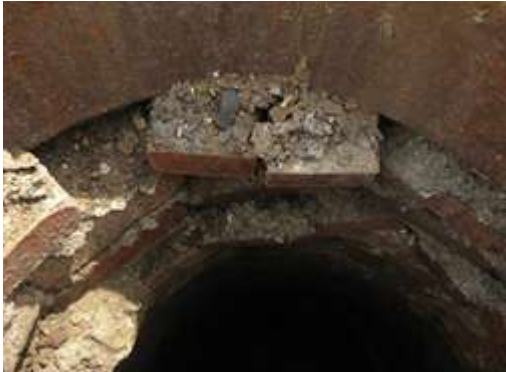
Defect 5

Condition: ☐ Sound ☐ Cracked ☐ Root Intrusion ☒ **Loose Brick** ☐ Deteriorated

loose bricks

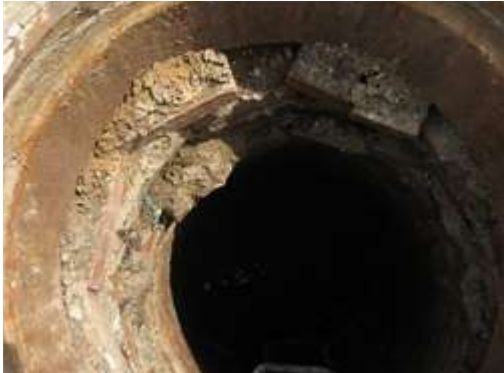
Defect 4

Frame Offset: **2.5** (in.) Condition: ☒ Sound ☐ Cracked ☐ Leaks

offset - deteriorated chimney

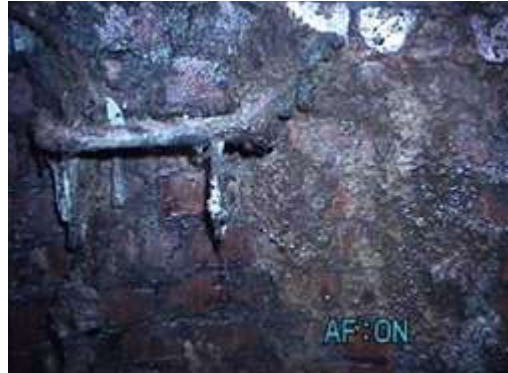
Defect 2

Surcharge ☒ **Evidence Of Surcharge** Depth: **9** (ft.) ☐ Active Surcharge Present

sign of surcharge on barrel

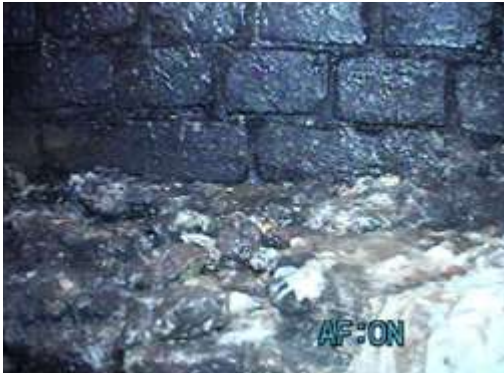
Defect 1

Condition: ☐ Sound ☐ Cracked ☐ Root Intrusion ☐ Deteriorated ☐ Leaks ☒ **Debris**

debris on bench

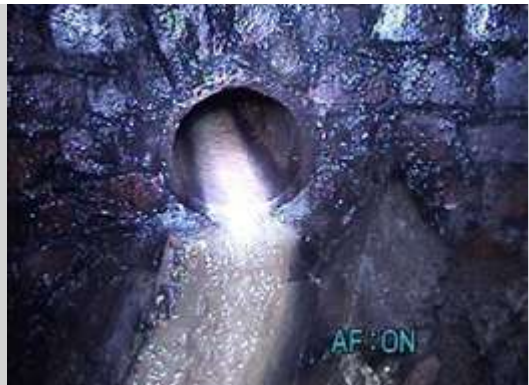
2 O'Clock Inflow

Pipe Height: **7.2** (in.) Rod and Bar (Angled)
Pipe Material: **Clay** ☐ Pipe Lined
Invert Depth: **12.31** (ft.) Flow Characteristics: **Fast**
Deposits: ☒ None ☐ Mud ☐ Sludge ☐ Debris ☐ Grease
Silt Depth: **0** (in.) Deposits Extent:
Infiltration: **Evidence** Pipe Seal Cond: **Unknown**
